**MICROMETEOROID IMPACTS ON THE HUBBLE SPACE TELESCOPE WIDE FIELD AND PLANETARY CAMERA 2: SMALLER PARTICLE IMPACTS.** D. K. Ross<sup>1,2</sup>, P. Anz-Meador<sup>1,2</sup>, J.C. Liou<sup>2</sup>, J. Opiela<sup>1,2</sup>, A. T. Kearsley<sup>3</sup>, G. Grime<sup>4</sup>, R. Webb<sup>4</sup>, C. Jeynes<sup>4</sup>, V. Palitsin<sup>4</sup>, J. Colaux<sup>4</sup>, T. Griffin<sup>5</sup>, L. Gerlach<sup>6</sup>, P. J. Wozniakiewicz<sup>3,7</sup>, M. C. Price<sup>7</sup>, M. J. Burchell<sup>7</sup>, and M. J. Cole<sup>7</sup> <sup>1</sup>Jacobs Technology, Houston Tx ([daniel.ross@nasa.gov](mailto:daniel.ross@nasa.gov)) <sup>2</sup>NASA-JSC, Houston, TX, USA <sup>3</sup>Science Facilities, Natural History Museum (NHM), London, SW7 5BD, UK <sup>4</sup>Ion Beam Centre, University of Surrey, Guildford, UK <sup>5</sup>NASA-GSFC, USA, <sup>6</sup>consultant to European Space Agency, ESA-ESTEC, Noordwijk, The Netherlands <sup>7</sup>School of Physical Science, University of Kent, Canterbury, CT2 7NH, UK.

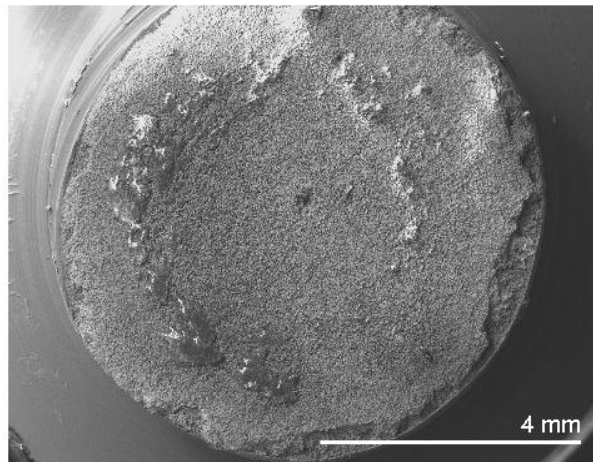
Fig. 1. WFPC2-97: Typical smaller micrometeoroid impact, Secondary Electron Image (SEI) of a core [2].

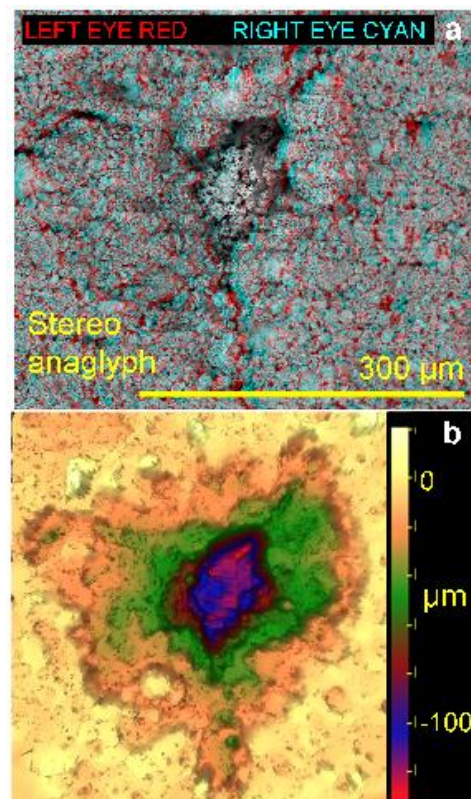
Fig. 2. WFPC2-339: a) Stereo anaglyph of BEI images; b) DEM shows crater is restricted to the ZOT paint layer, and does not excavate the underlying Al alloy.

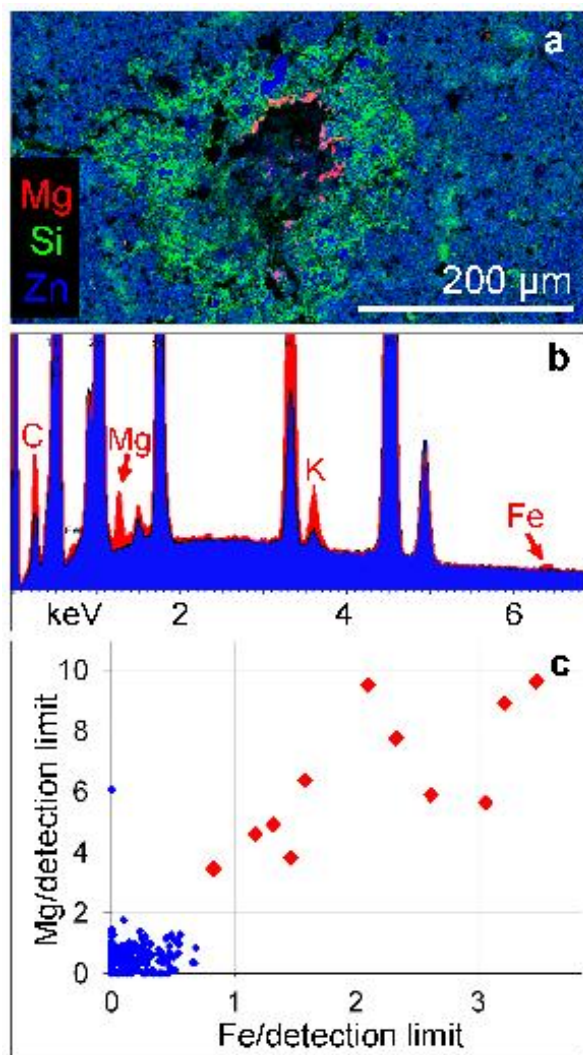
ZOT paint.. Comparison of EDX spectra to clean paint composition showed that locally, impact melts had enrichment of Mg and Fe (e.g. Fig. 3) without significant increase in Al, indicating that these elements were not derived from the alloy beneath. These resemble silicate MM analogue impacts [4]. A few craters contained Fe and Ni enrichments, indicating probable MM metal, or Fe and S (e.g. Fig. 4) like experimental sulfide MM analogues of [4].

Fig. 3. WFPC2-339: a) EDX maps show Mg enriched in melt around pit; b) EDX spectrum melt (red) compared to unaltered paint (blue); c) Mg and Fe enrichment in frothy melt (red), above levels in paint (blue).

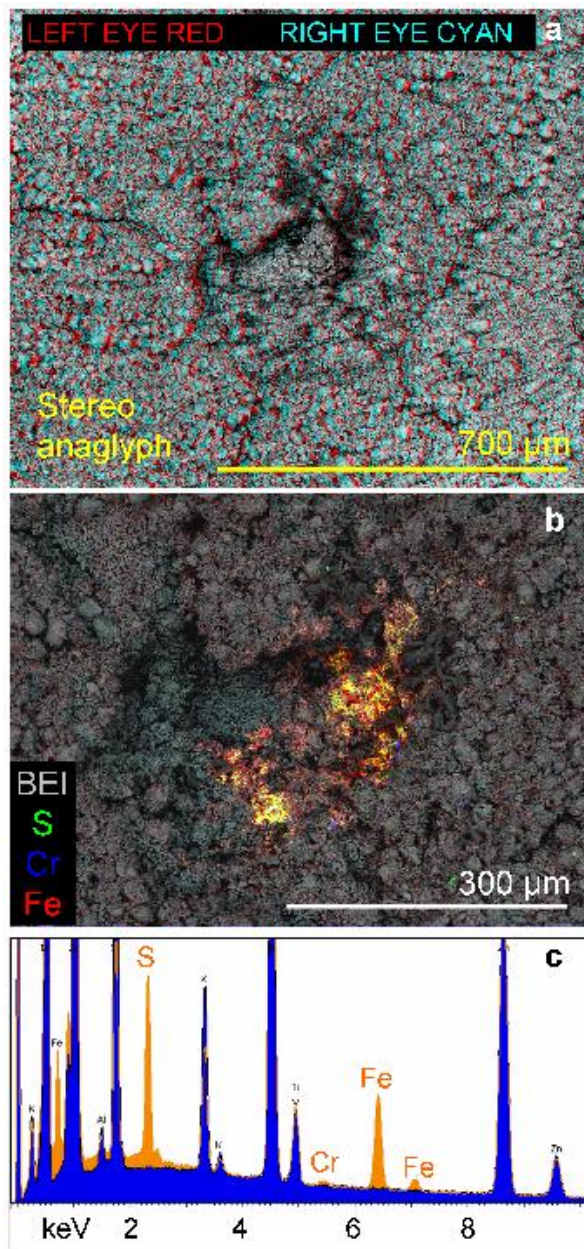
Fig. 4. WFPC2-156: a) BEI stereo anaglyph; b) EDX maps show Fe and S enriched in melt; c) EDX spectrum melt (orange) compared to unaltered paint (blue).
